2183 USPS Processing & Distribution Ctr REPORT
Multnomah
Final Closure Report April 12, 2012

Final Closure Report

**USPS Portland P&DC
715 Northwest Hoyt Street
Portland, OR 97208**

April 2012

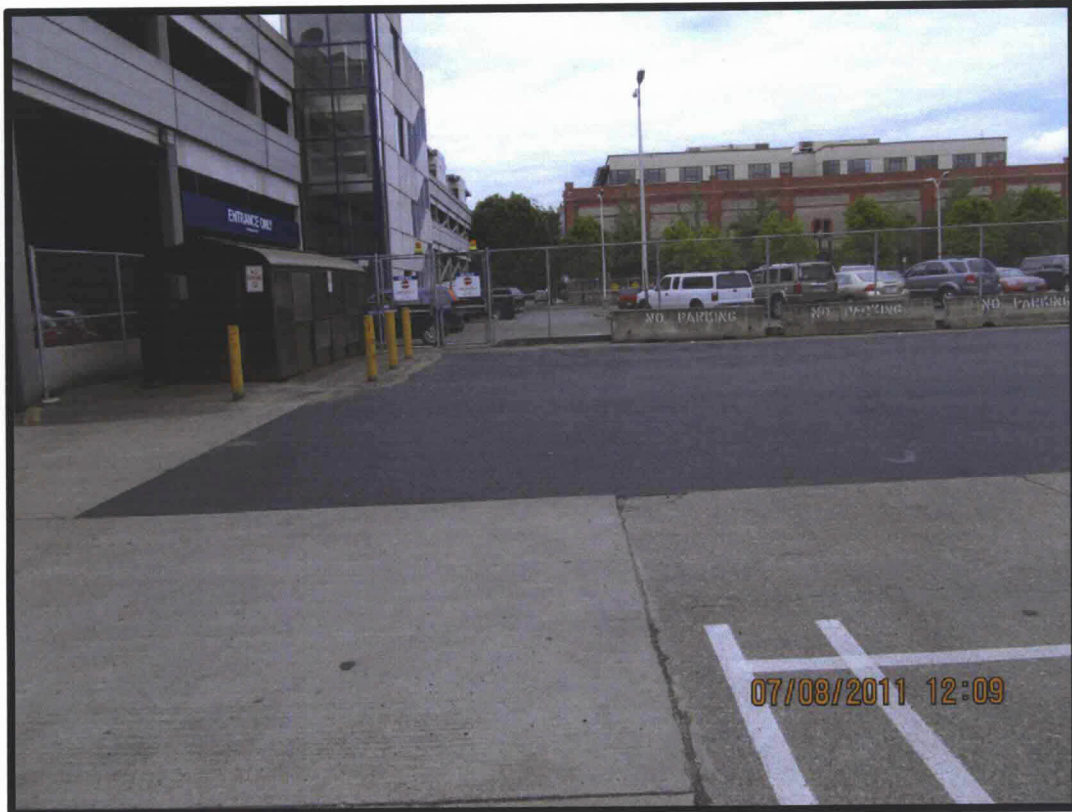
Photo 6 - Looking westerly at pavement repair in west truck dock area.

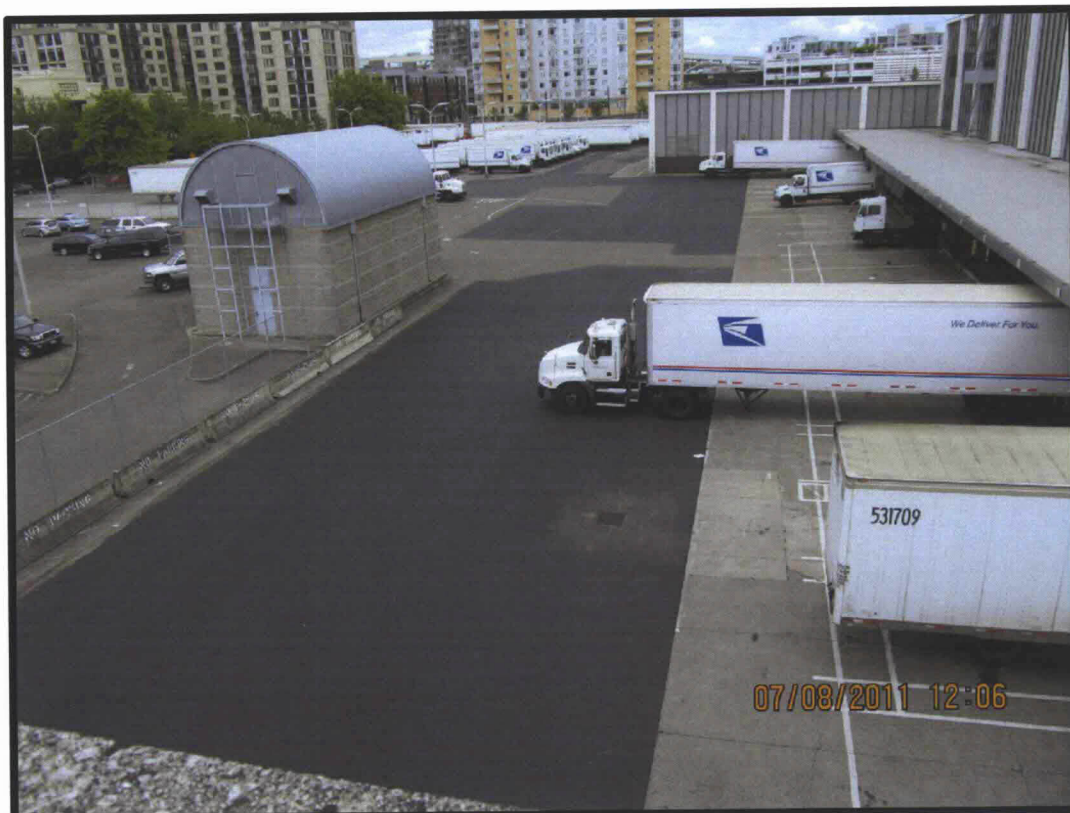
Photo 7 - Looking northerly at pavement repair in west truck dock area.

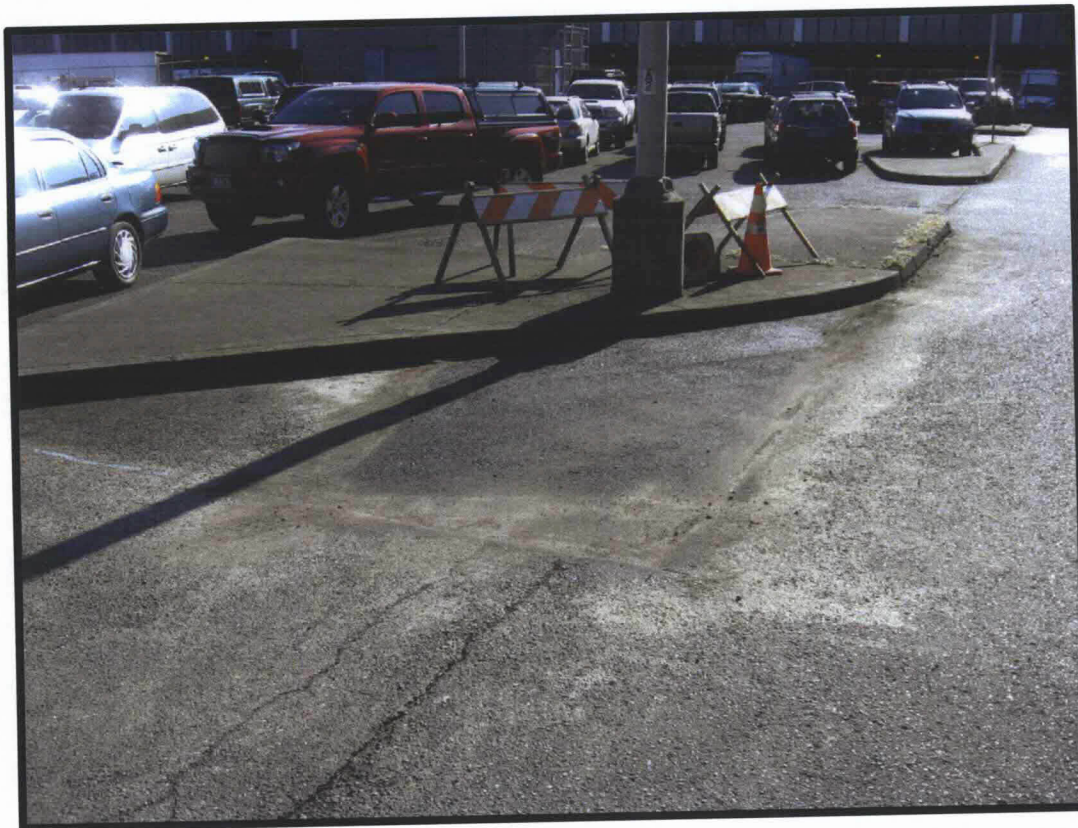
Photo 9 - Looking easterly at repair adjacent to concrete curbing in employee parking lot (near northwest corner of employee parking garage) (repair on August 3, 2011).
